SAP Land and Architecture. 2025; 4:251
doi: 10.56294/la2025251

Analysis and proposals for an inclusive classroom block

[1]Universidad CESMAG. Colombia.

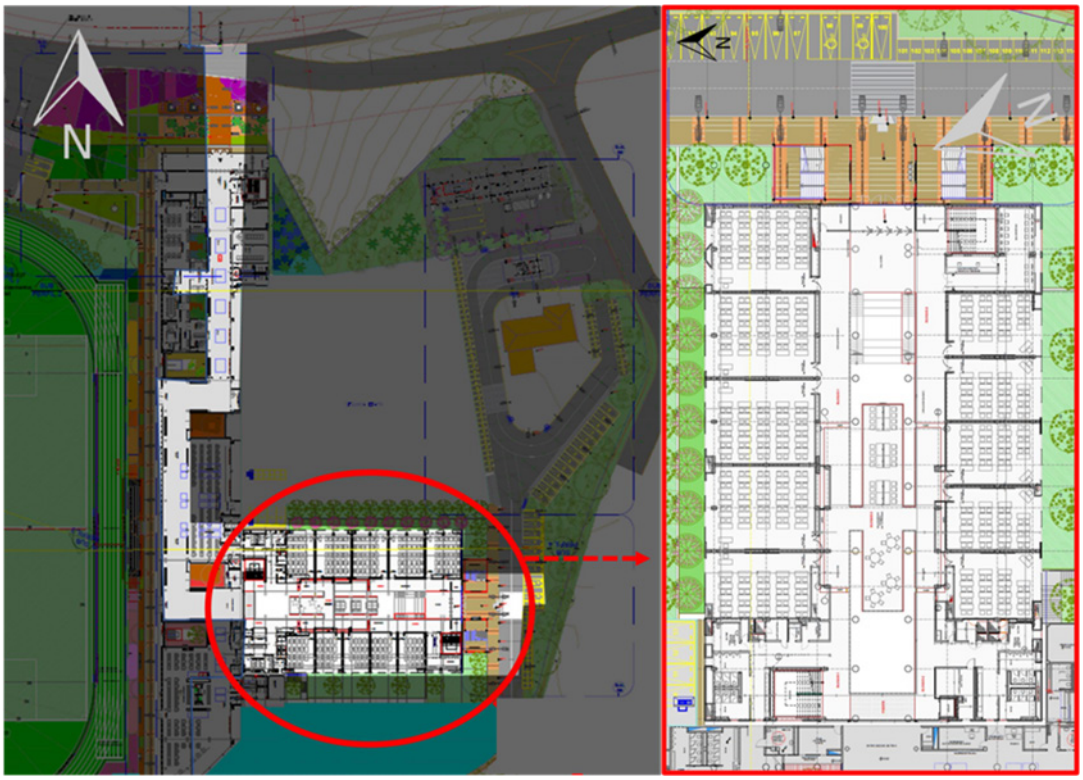
Figure 1. Subject of study: Medio Universitario San Damián classroom block and associated access routes[4]

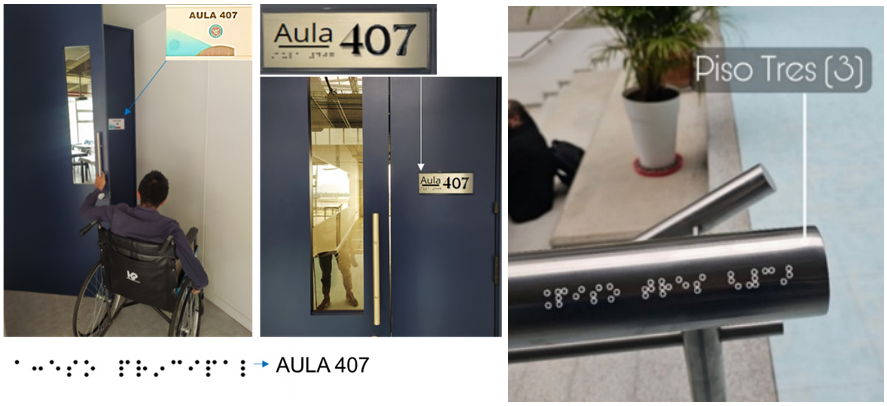
The current classroom markings consist of a sign with the classroom number in fairly small print and without any kind of relief. It is proposed that the classroom number be marked in Braille below the conventional number. This tactile signage would allow people with visual impairments to easily identify the classroom number and access it independently.

Figure 13. Imaginary and Braille demarcation in classrooms and corridors

To improve orientation for people with visual impairments in the classroom block, we propose the implementation of Braille signage on stair handrails. This signage, located at the beginning or end of the handrail, would indicate the floor number in Braille. Other relevant information could also be included in the signage, such as the location of classrooms or services on that floor, to facilitate orientation and independent mobility.

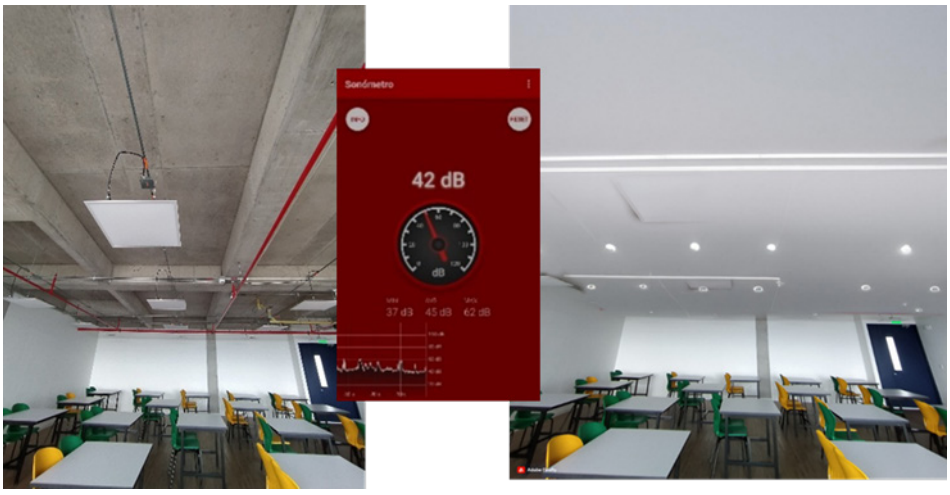
Noise measurements taken in the classroom block recorded a minimum noise level of 37 dB with an average voice tone, which exceeds the recommended limit of 20 to 30 dB for classrooms, where optimal acoustic comfort is sought. To improve the acoustics of the space and create a more comfortable and functional environment for users, we propose installing an acoustic ceiling that absorbs sound waves and reduces reverberation. We also suggest incorporating other acoustic design strategies, such as the use of absorbent panels on the walls. Even with a good acoustic environment, people with hearing impairments may have difficulty hearing at a certain distance from the sound source. Therefore, communication systems that improve sound reception, such as magnetic induction loops, should be included. These systems allow the audio signal to be transmitted directly to hearing aids or cochlear implants, improving sound clarity and intelligibility.

Figure 14. Concept for classroom sound systems

It is important to note that, for people with hearing impairments, sound quality is not limited to noise level alone. The level, frequency, and clarity of sounds are also crucial for a good listening experience. If echoes interrupt sounds, words or lectures may be unintelligible to them. Likewise, if frequencies are too high, they can cause discomfort or even pain. Considering these aspects is key to the inclusive design and functionality of the building.
